Contract #: 04-0120F4Cty: SF/ALA Rte: 80 PM: 13.2/13.9File #: 99.28**WELDING INSPECTION REPORT****Resident Engineer:**Siegenthaler, Peter**Address:** 333 Burma Road**City:** Oakland, CA 94607**Report No:** WIR-019011**Date Inspected:** 02-Jan-2011**Project Name:** SAS Superstructure**OSM Arrival Time:** 700**Prime Contractor:** American Bridge/Fluor Enterprises, a JV**OSM Departure Time:** 1900**Contractor:** Zhenhua Port Machinery Company, Ltd (ZPMC)**Location:** Shanghai, China**CWI Name:** Li Yang and Zhu Zhong Hai**CWI Present:** Yes No**Inspected CWI report:** Yes No N/A**Rod Oven in Use:** Yes No N/A**Electrode to specification:** Yes No N/A**Weld Procedures Followed:** Yes No N/A**Qualified Welders:** Yes No N/A**Verified Joint Fit-up:** Yes No N/A**Approved Drawings:** Yes No N/A**Approved WPS:** Yes No N/A**Delayed / Cancelled:** Yes No N/A**Bridge No:** 34-0006**Component:** OBG Trial Assembly**Summary of Items Observed:**

Orthotropic Box Girder (OBG) at Trial Assembly Areas

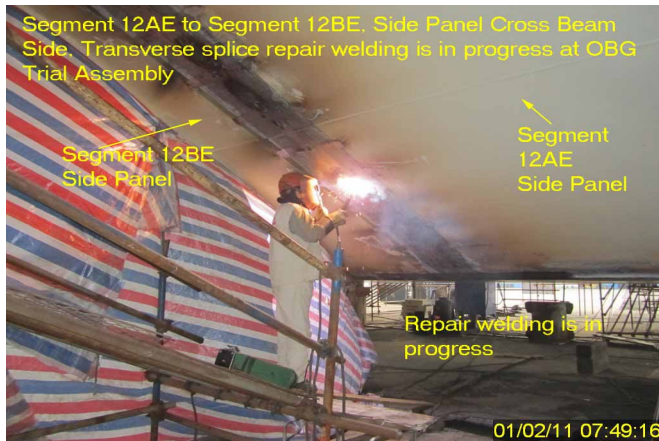
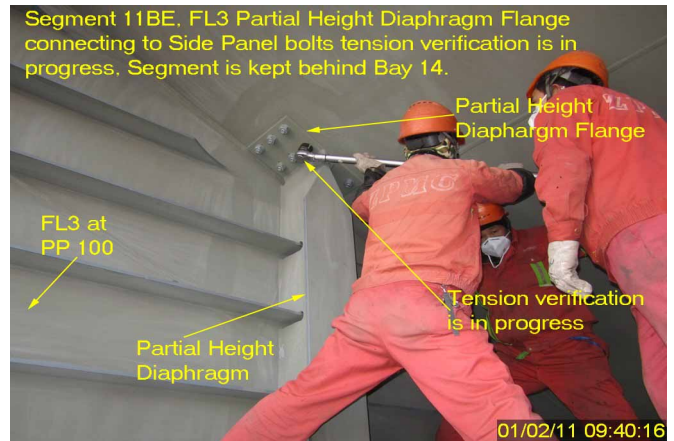
This QA Inspector witnessed the final bolt tension verification on bolts connecting the Partial Height Diaphragm flange to the Side Panel at FL3 location at Panel Points (PP) 98, PP 99 and PP 100 for Segment 11BE. The QA Inspector verified the bolt tension on a random basis and the results appeared to be in general compliance. The Inspection was performed against Notification No. 00592 dated January 02, 2011.

The bolt sizes used were M24 x 65 RC Lot # DHGM240013 and the final torque value established was 540 N-m.

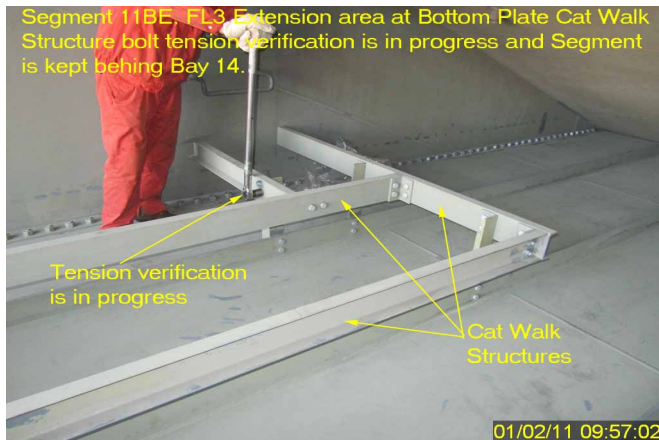
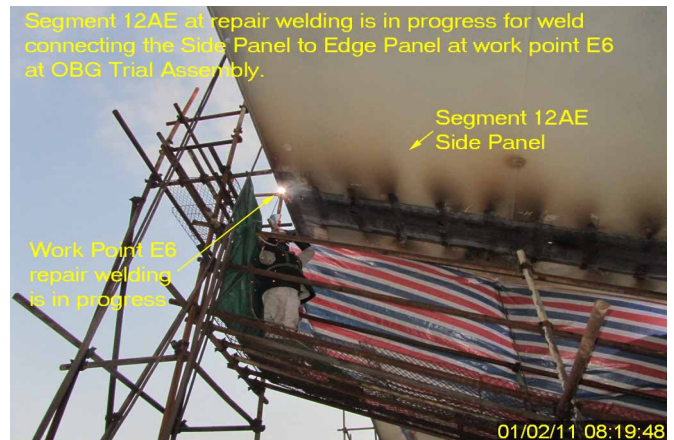
This Quality Assurance (QA) Inspector witnessed final bolt tension verification for Catwalk structure which is connected to Bottom Panel T-Ribs at Panel Point (PP) 98 and PP 99 for Segment 11BE at Bottom Panel. Inspected 10% on a random basis and found the tension to be in general compliance. Inspection was performed against the Notification No. 00592 Dated January 02, 2011.

Bolt sizes used were M16 x 45 RC Set# DHGM160021 and final torque required was 180 N-m.

Bolt sizes used were M16 x 50 RC Set# DHGM160011 and final torque required was 200 N-m.

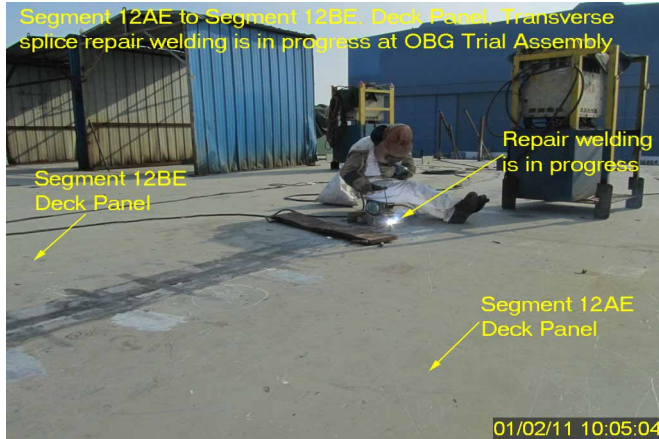
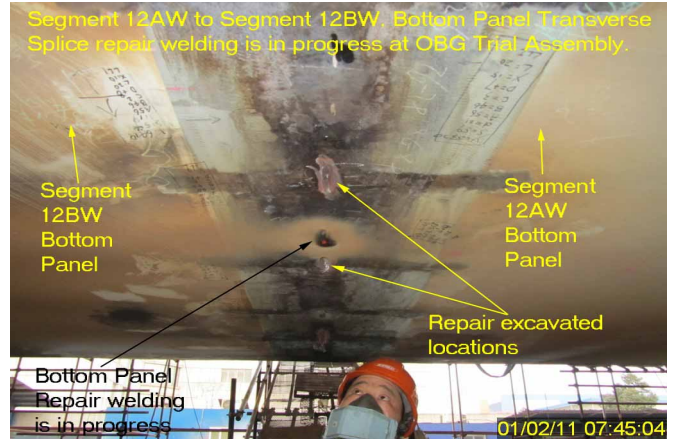
This QA Inspector observed the repair welding by Shielded Metal Arc Welding (SMAW) process on a Complete Joint Penetration (CJP) groove weld. The Weld joint was designated as OBW12-003. The welder identification was 044515 and observed welding in the 1G (Flat) position using approved Welding Procedure Specification WPS-345-SMAW-1G(1F)-FCM-Repair-1. The piece marks was identified as the Deck Panel, at transverse splice. ZPMC performed repair welding in accordance with Critical Welding Repair Report B-CWR2634 dated Dec 31, 2010.
